Manhole Inspection Summary

Manhole # S03GG2001MH

Insp Date: **7/11/06 8:25 AM**

Location Address: **6401 APOLLO DR**

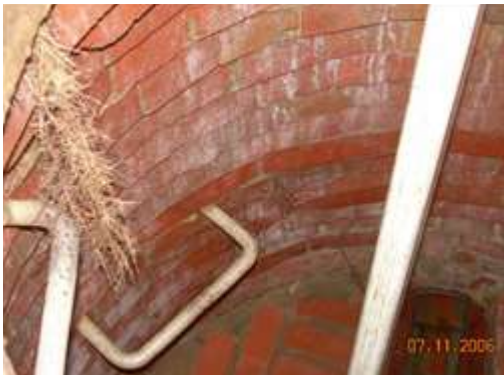
Defect

Frame leaks. Adjustment and Barrel root intrusion. Adjustment, Corbel, and barrel infiltration.

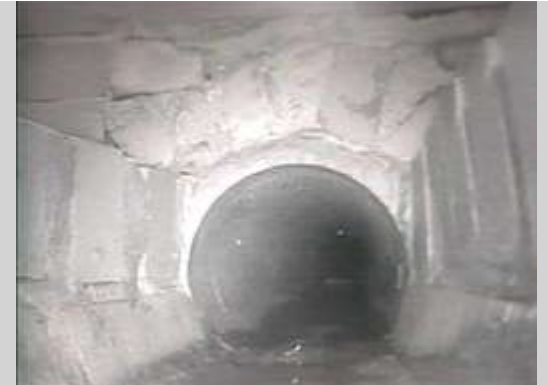
8 in. Circular Gravity Sewer Pipe Out @ 12 O'Clock

Infiltration: **Evidence** Pipe Seal Cond: **Unknown**

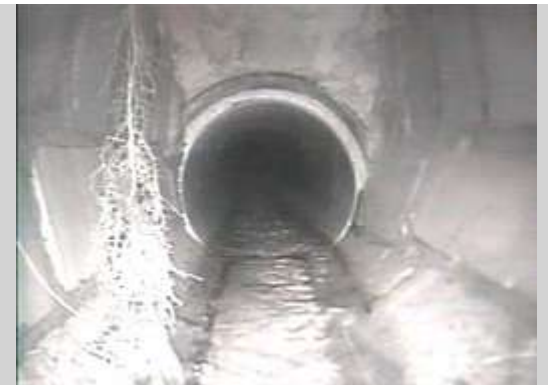
6 in. Circular Gravity Sewer Pipe In @ 6 O'Clock

Comments **The I6 pipe seal is not flush to the pipe. The I6 pipe picture shows Channel root intrusion.**

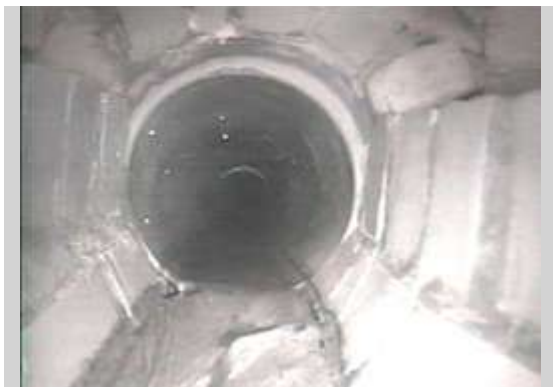
8 in. Circular Gravity Sewer

Infiltration: **Evidence**
